# BUILDING AND TIMBER PEST INSPECTION

Complies with Australian Standard AS 4349.1-2007 & AS 4349.3-2010  
Inspection of Buildings Part 1 & Part 3: Pre-Purchase  
Inspections of Residential Buildings - Appendix C

Jul 31, 2023

21 SMITH STREET  
BAULKHAM HILLS, NSW  
2153, Australia

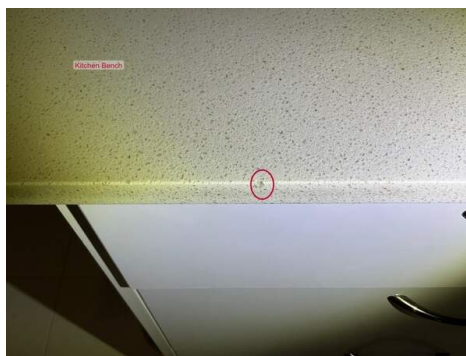
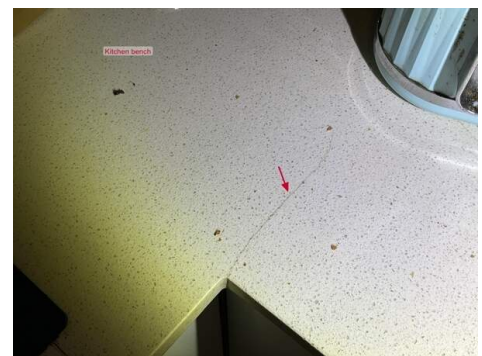
### 7.3.1 Minor chipping/cracking to benchtop edge evident

Building:	Main Building
Area:	Interior
Location:	Kitchen
Defect Significance:	Minor Defect
Defect Type:	A (Damage)

Recommended trade to be contacted: Stone Polisher

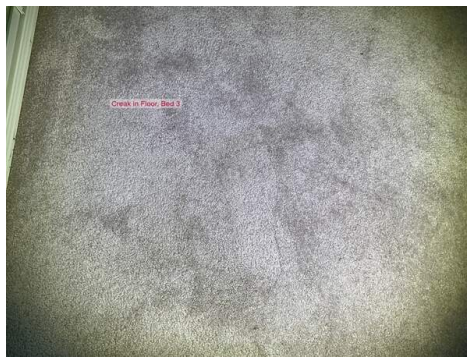
### 7.3.2 Minor creak and bounce evident to floor area

Unfinished or substandard building works are likely to degrade more quickly and may create potential for secondary defects.

EXPLANATIONS	<b>Building:</b>	Main Building
	<b>Area:</b>	Interior
	<b>Location:</b>	Bedroom 3
	<b>Defect Significance:</b>	Minor Defect
	<b>Defect Type:</b>	D (Material Deterioration)

Recommended trade to be contacted: Carpenter or Floor Covering Specialist

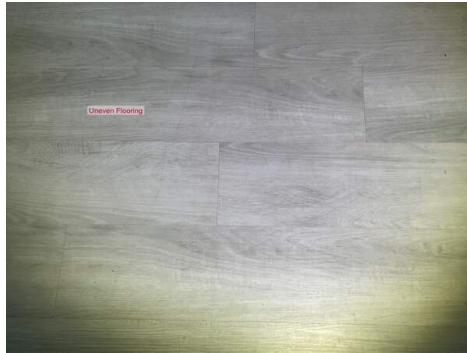
### 7.3.3 Flooring - Uneven in Sections

Unfinished or substandard building works are likely to degrade more quickly and may create potential for secondary defects.

EXPLANATIONS	<b>Building:</b>	Main Building
	<b>Area:</b>	Interior
	<b>Location:</b>	Front Entry
	<b>Defect Significance:</b>	Minor Defect
	<b>Defect Type:</b>	F (Installation or Non Installation)

Recommended trade to be contacted: Carpenter

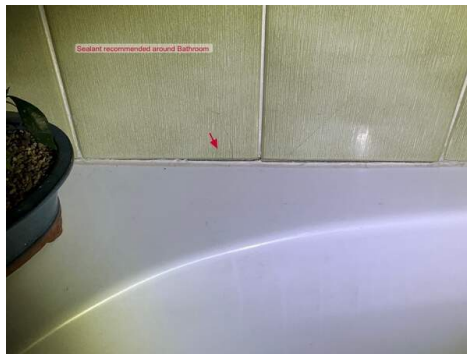
### 7.3.4 Sealant - Recommended (Wet Area)

Different materials and floor areas move at different rates, generally causing cracking to grout or sealant at this point.

Building:	Main Building
Area:	Interior
Location:	Bathroom
Defect Significance:	Minor Defect
Defect Type:	F (Installation or Non Installation)

Flexible and mould resistant materials should be applied to affected areas to prevent any secondary issue. Regular maintenance and replacement of damaged or missing or sealant and grout is highly recommended to the wet areas, as this is a regular wear and tear defect.

Sealant and grouting in areas that come into regular contact with water should be maintained for the long term care of your property. A sealant specialist or tiling contractor is recommended to be appointed to complete these works at the earliest convenience.

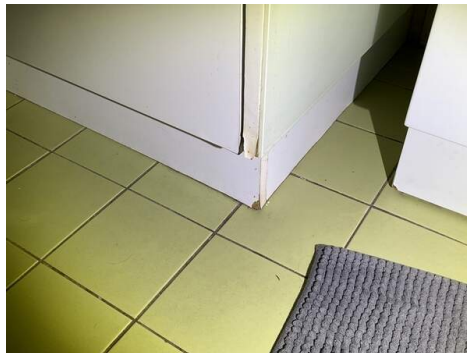
### 7.3.5 Moisture Damage - Observed

This building element shows evidence of moisture damage.

If left unmanaged, damp conditions can lead to further health problems and the decay of timbers may also continue. Early intervention and regular maintenance, particularly of exterior timbers, will prolong the useful life of these building elements.

Building:	Main Building
Area:	Interior
Location:	Bathroom
Defect Significance:	Minor Defect
Defect Type:	C (Moisture, Water Penetration or Damp Related)

Prior to any works being performed, the cause of the moisture that has created the visible damage should be identified and addressed without delay.

Replacement of affected timbers may then be a necessary step in protecting surrounding building elements from such deterioration.

A qualified carpenter could be engaged to replace affected building materials.

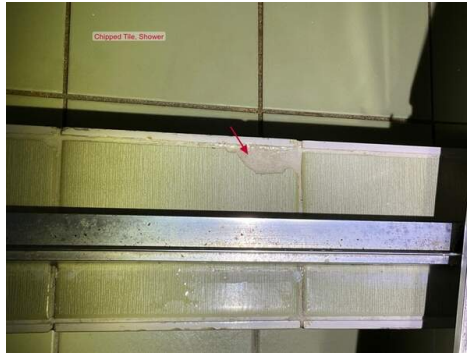
### 7.3.6 Tiles - Cracked or Damaged

Cracking was evident to the tiling in this area at the time of inspection.

Building:	Main Building
Area:	Interior
Location:	Bathroom
Defect Significance:	Minor Defect
Defect Type:	A (Damage)

While the damage appears to be minor, if left unmanaged, water penetration to surrounding areas may lead to secondary water damage, which is likely necessitate repair work to other affected building elements. A tiling contractor should be appointed to replace affected tiles as well as a leak detection specialist to ensure the area has not encountered water egress as a result.

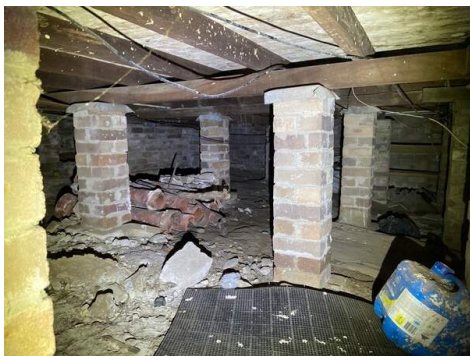
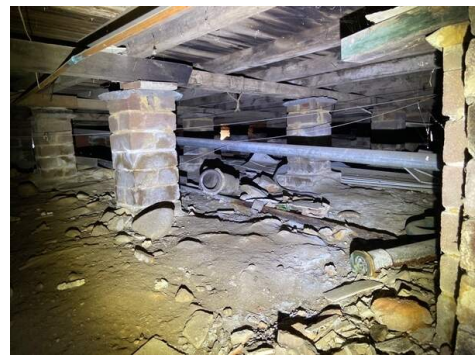
### 7.3.8 In Ground Contact - Stored Timbers

Any timbers in direct ground contact provide opportunity for concealed termite entry and are likely to be subject to premature rot and decay as the soil retains moisture or damp conditions against the timbers.

EXPLANATIONS	Building:	Main Building
	Area:	Subfloor
	Location:	Subfloor
	Defect Significance:	Minor Defect
	Defect Type:	F (Installation or Non Installation)

Remove untreated timber that is in direct contact with external grounds. Consider replacement with more durable materials i.e. treated timber or non timber elements.

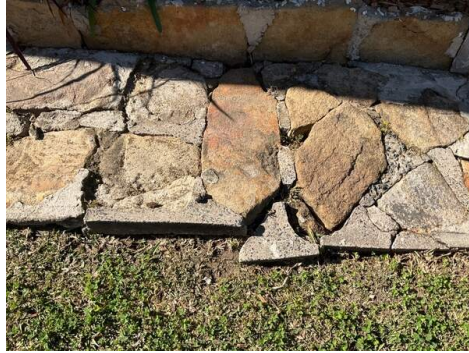
### 7.3.9 Paving - Uneven/Cracking

Paving in some instances may create a trip hazard, personal due caution is to taken by all persons within this area.

EXPLANATIONS	Building:	Main Building
	Area:	Exterior
	Location:	Front Elevation
	Defect Significance:	Minor Defect
	Defect Type:	D (Material Deterioration)

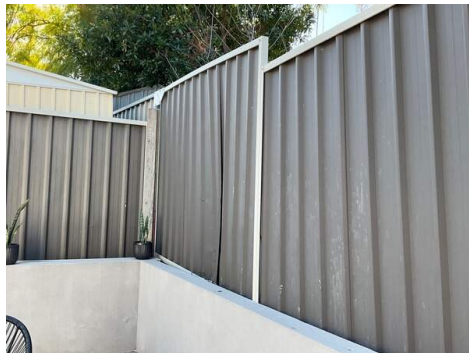
7.3.10 Fencing - Deteriorated in sections or leaning

It was noted at the time of inspection that sections of the fencing throughout the property have deteriorated to areas as shown.

Typically fencing deteriorates due to age and or wear, rot and or rust which is generally expected for a structure of this age, due to prolonged exposure to weather conditions. Sometimes inadequate installation or maintenance can be to blame. If left unattended, it is likely that further damage will occur.

Building:	Main Building
Area:	Exterior
Location:	Fencing
Defect Significance:	Minor Defect
Defect Type:	D (Material Deterioration)

It is suspected that repair of several elements of the fencing may be required however replacement may be a consideration of the client also.

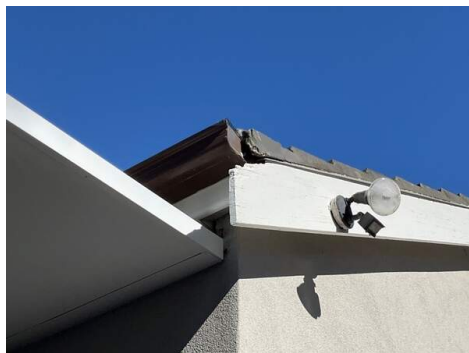
### 7.3.11 Fungal Decay (Wood Rot) - Observed

This building element shows evidence of wood rot.

Wood rot, also known as Fungal Decay, occurs when timbers and other cellulose building materials are exposed to damp conditions on an ongoing basis. This could be the result of exposure to weathering over a prolonged period of time, or the attraction of excessive moisture from other abutting building materials. Contributing factors also include poor air ventilation in the area.

EXPLANATIONS	<b>Building:</b>	Main Building
	<b>Area:</b>	Exterior
	<b>Location:</b>	Rear Elevation
	<b>Defect Significance:</b>	Minor Defect
	<b>Defect Type:</b>	C (Moisture, Water Penetration or Damp Related)

If left unmanaged, damp conditions can lead to further health problems and the decay of timbers will continue. Early intervention and regular maintenance, particularly of exterior timbers, will prolong the useful life of these building elements. Prior to any works being performed, the cause of the moisture that has created the visible wood rot should be identified and addressed in a suitable manner.

Replacement of affected timbers may then be a necessary step in protecting surrounding building elements from such deterioration.

A qualified carpenter or registered builder may also be required to replace affected building materials.

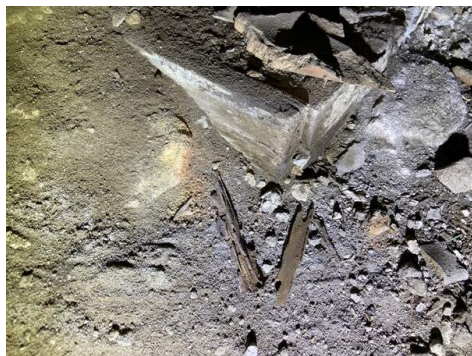
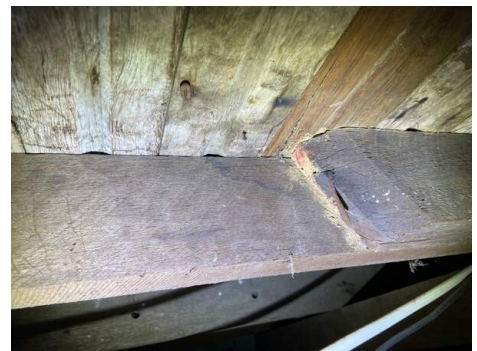
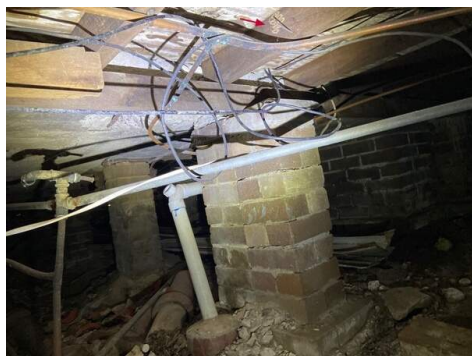
## 7.5.1 Evidence of Termite Workings - Observed

Evidence was found at the time of inspection to suggest that termite activity has been present on the property including past workings, and possible concealed damage.

EXPLANATIONS	Building: Main Building Area: Subfloor Location: Subfloor Defect Significance: Timber Pest Damage Defect Type: A (Damage)
--------------	---

Visible evidence of subterranean termite activity, workings such as mud packing, and or leads or termite damage was found at the time of the inspection to the subfloor area. A follow up invasive inspection is recommended to completely rule out any concealed damage or activity.

It is strongly recommended that at first a thermal image inspection of the structural framework be carried out without delay. In the event of the discovery of activity or damage we then recommend an invasive inspection to completely ascertain the extent of the concealed damage or activity by a specialist Invasive Termite Inspector.

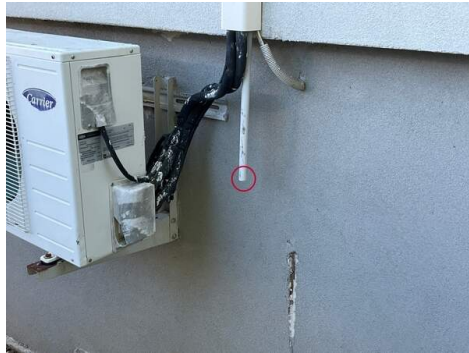
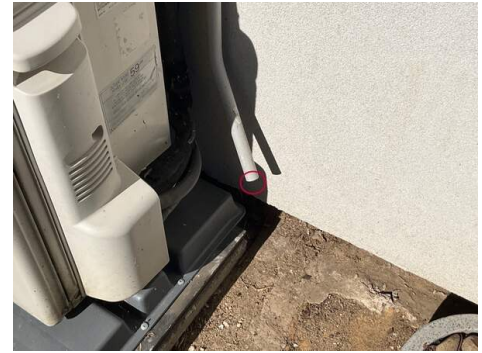
## 7.6.2 Air Conditioner Overflow not Connected

The Air Conditioner (AC) overflow was found to be disconnected from storm water drainage and may create excessive moisture in the surrounding area.

Such leaking may create an environment which is conducive to an array of defects, including water damage to associated building elements and the attraction of termite or timber pest infestation.

EXPLANATIONS	Building:	Main Building
	Area:	Exterior
	Location:	Side Elevation
	Defect Significance:	Conditions Conducive to Timber Pest Activity
	Defect Type:	C (Moisture, Water Penetration or Damp Related)

It is highly recommended that a licensed plumber be appointed to connect the A/C overflow in order to prevent such an environment from being created.

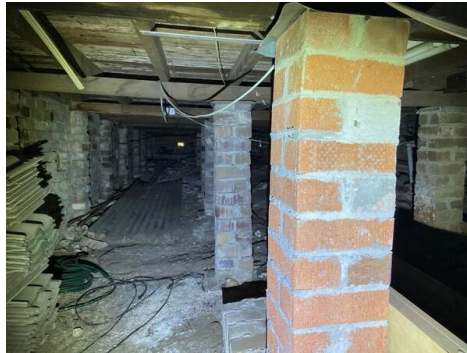
Unfinished or substandard building works are likely to degrade more quickly and may create potential for secondary defects.

Building:	Main Building
Area:	Subfloor
Location:	Subfloor
Defect Significance:	For Information Purposes
Defect Type:	F (Installation or Non Installation)

Recommended trade to be contacted: Builder

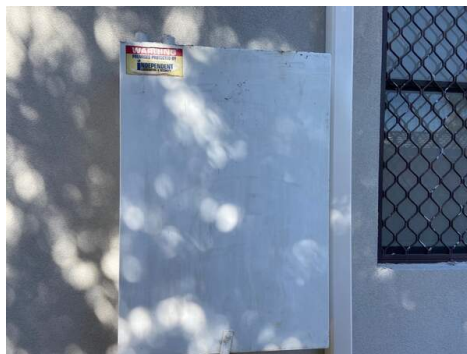
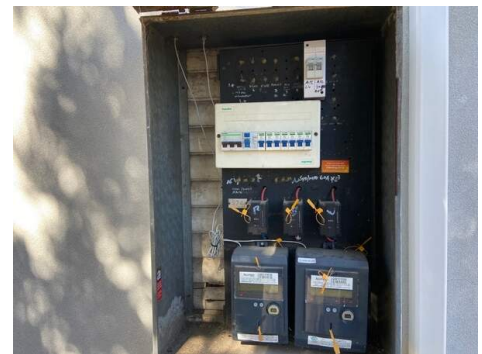
### 7.7.2 Termite Management System - Recommended

Building:	Main Building
Area:	Exterior
Location:	Meter Box
Defect Significance:	For Information Purposes
Defect Type:	Information

The application of a post-construction chemical or physical termite barrier is highly recommended for all properties. Such barriers are highly effective in preventing termite attack on any timber building elements throughout the property.

It is strongly recommended that obtaining such advice be a short-term priority.

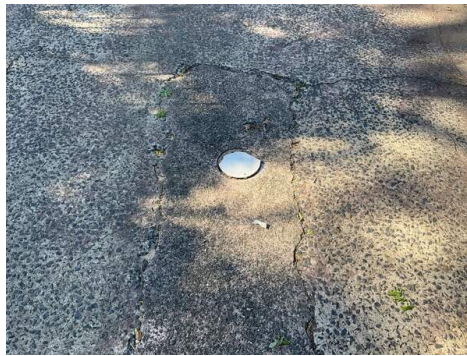
### 7.7.3 Evidence of a Termite Barrier or Management System (TMS) was Identified

Building:	Main Building
Area:	Exterior
Location:	Side Elevation
Defect Significance:	For Information Purposes
Defect Type:	Information

Where a Termite Management System has been identified you should refer to the type of barrier date of installation warranty conditions and any documentation provided by a builder or past owner. Consult the company who installed the barrier to confirm whether the system is still under warranty.
