# BUILDING AND TIMBER PEST INSPECTION

Complies with Australian Standard AS 4349.1-2007 & AS 4349.3-2010  
Inspection of Buildings Part 1 & Part 3: Pre-Purchase  
Inspections of Residential Buildings - Appendix C

Jul 31, 2023

21 SMITH STREET  
BAULKHAM HILLS, NSW  
2153, Australia

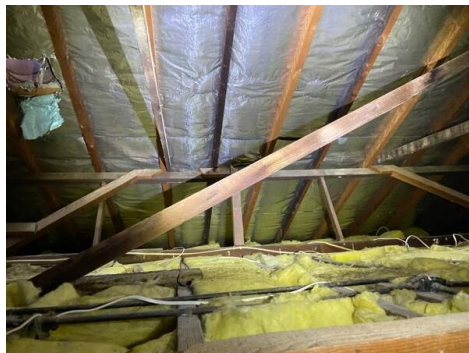
Photo Ref #25

EXPLANATIONS	Building: Main Building Area: Roof Void Location: Roof Space Finding Significance: For Information Purposes Comments: Bulk Insulation and Low Clearance
--------------	---

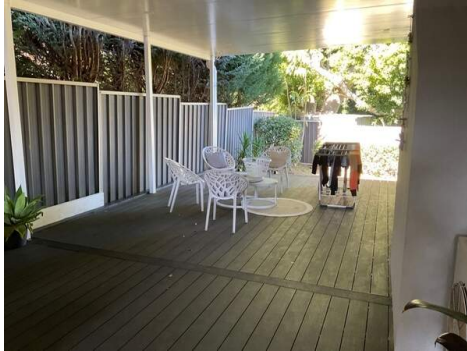
Photo Ref #43

Building: Main Building  
Area: Exterior  
Location: Yard Rear  
Finding Significance: For Information Purposes  
Comments: Furniture and Decking
